USDA Forest Service Aviation Safety Summary September/October 2001

Information Sharing

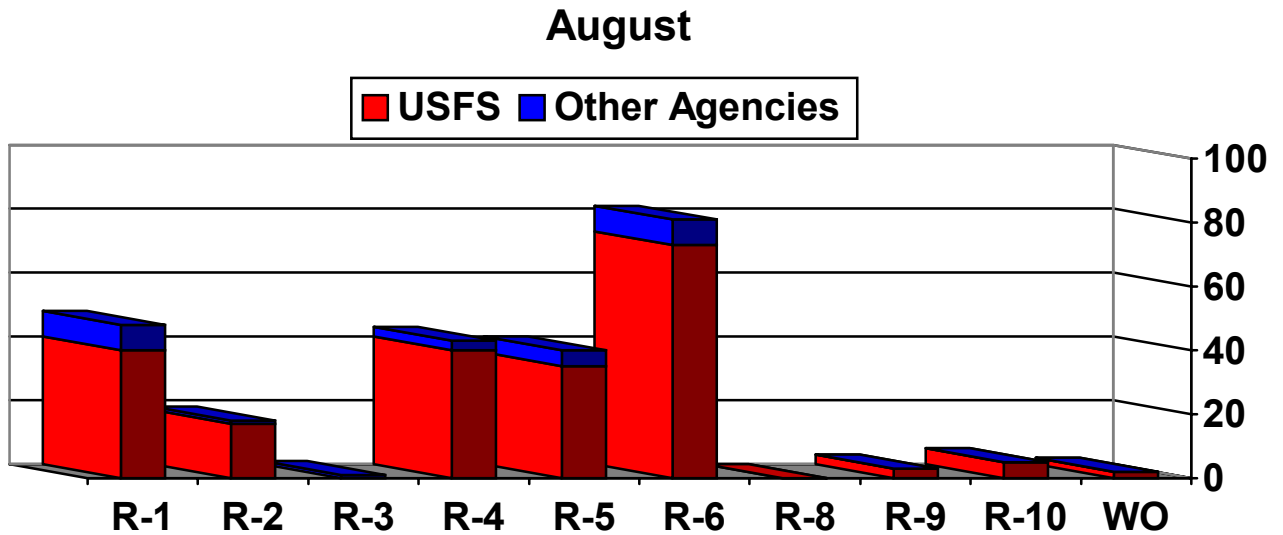
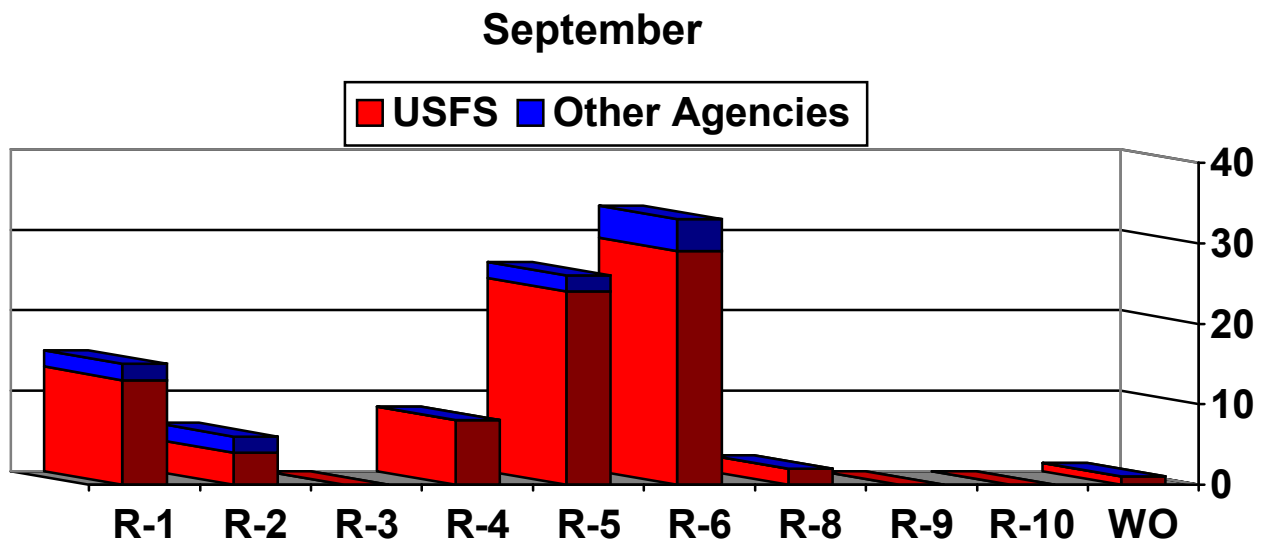
SafeComs by Region

The charts below shows the number of SafeComs by region (FS and other agency) reported for August and September of this year.

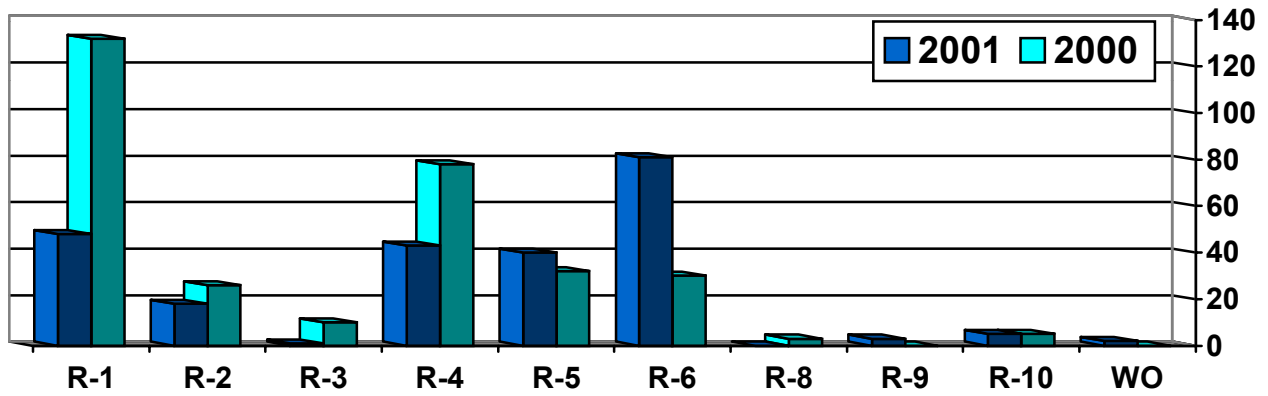
The following charts show the total number of SafeComs reported by region for August and September of this year and last year.

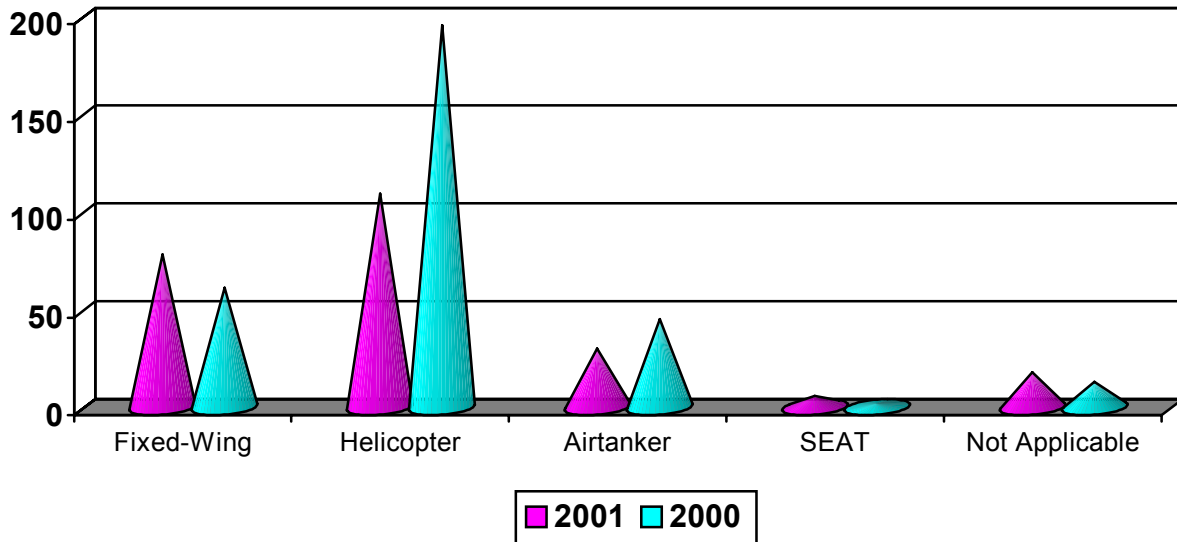
In August helicopter SafeComs accounted for 44% of the SafeComs this year compared to 62% last year. Fixed-wing SafeComs were up from 19% last year to 33% this year. The percent of Airtanker SafeComs were comparable at 13% this year and 14% last year. The chart below show the number of SafeComs reported by aircraft type for this year and last year.

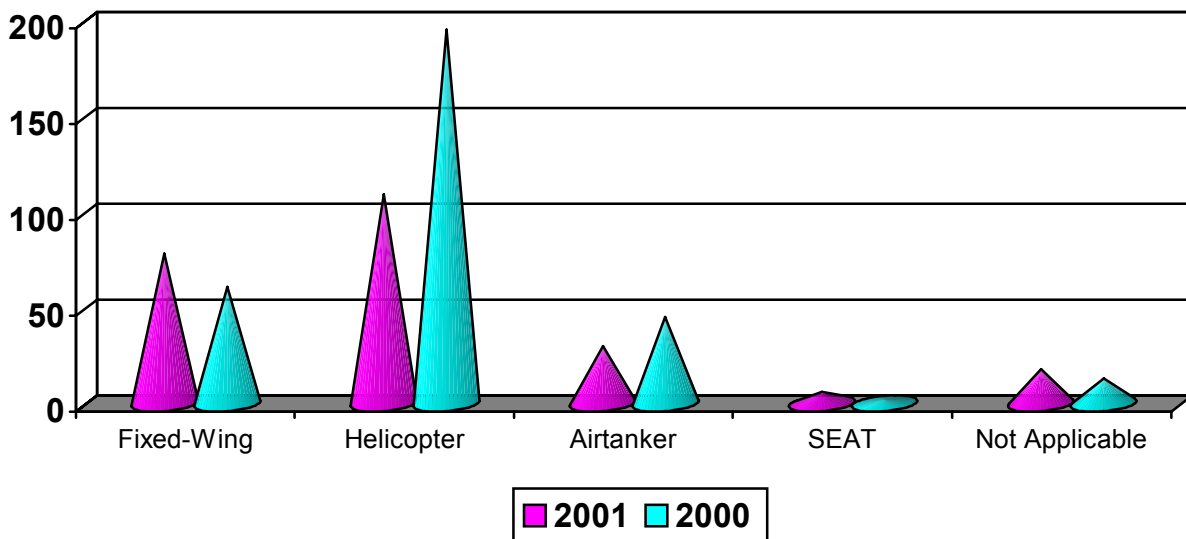
In September helicopter SafeComs were much higher accounting for 62% of the SafeComs this year and 73% last year. Airtanker SafeComs were comparable to August at 13%, but much higher than the 3% reported last September. Fixed-wing SafeComs were comparable, this year at 21% and 23% last year.

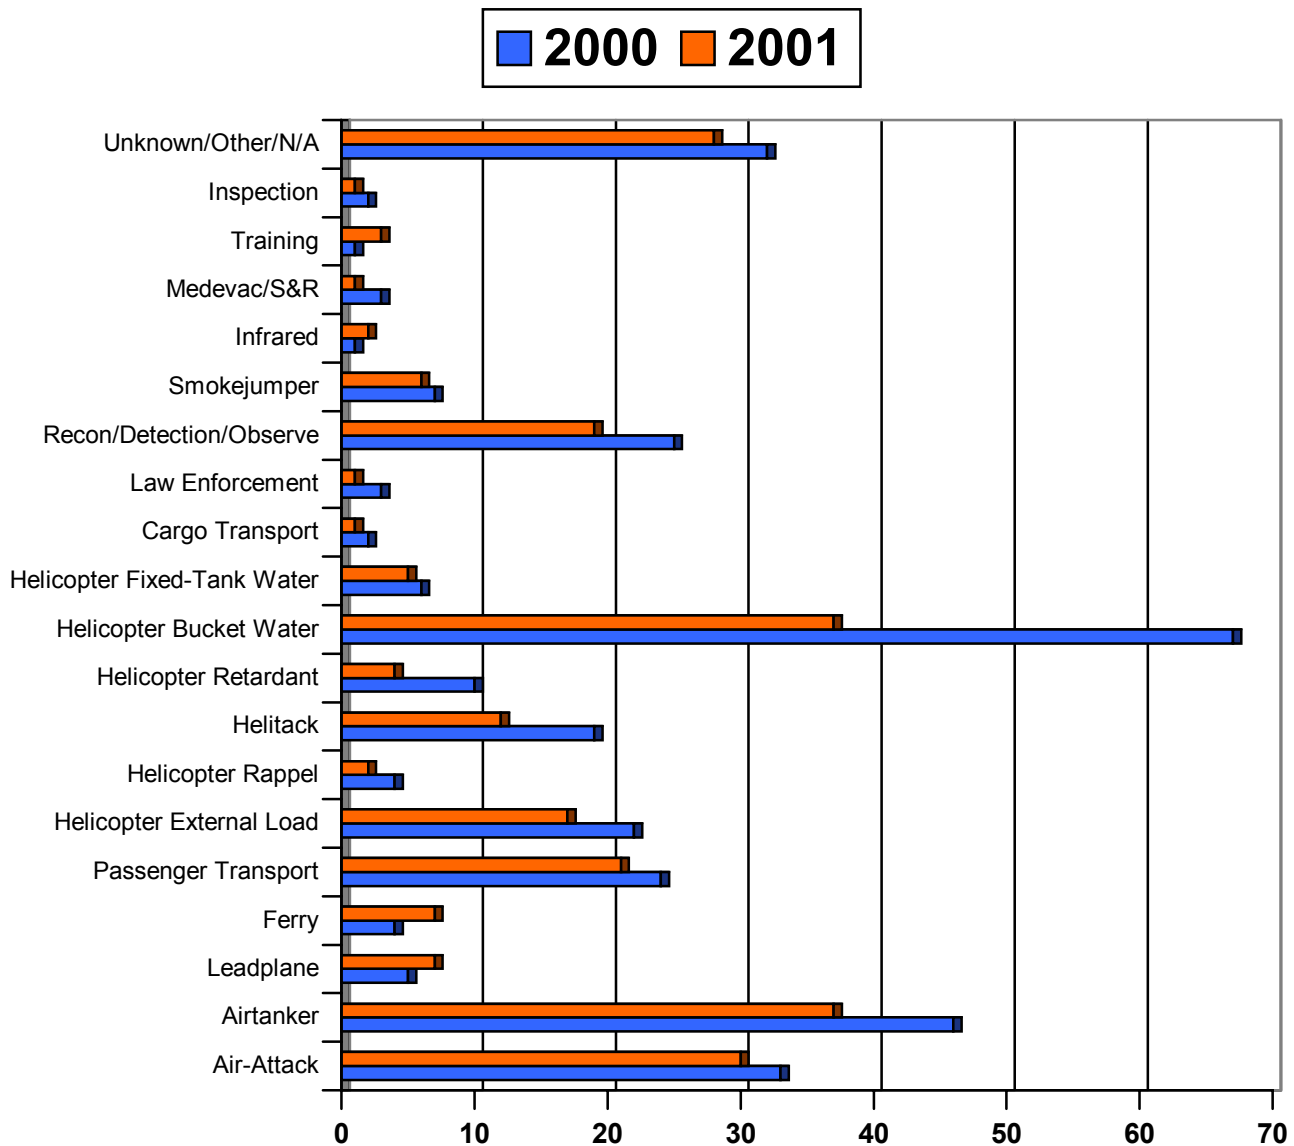
August

Airtanker retardant drops and helicopter bucket drops were equally the highest number of SafeComs reported this year. Last year helicopter bucket drops were far higher than any other mission. Air-attack followed by passenger transport followed behind Passenger transport SafeComs continue with the same trend, coming in third place. Helicopter External Loads and Air-Attack missions were both considerably higher this year compared to last year.

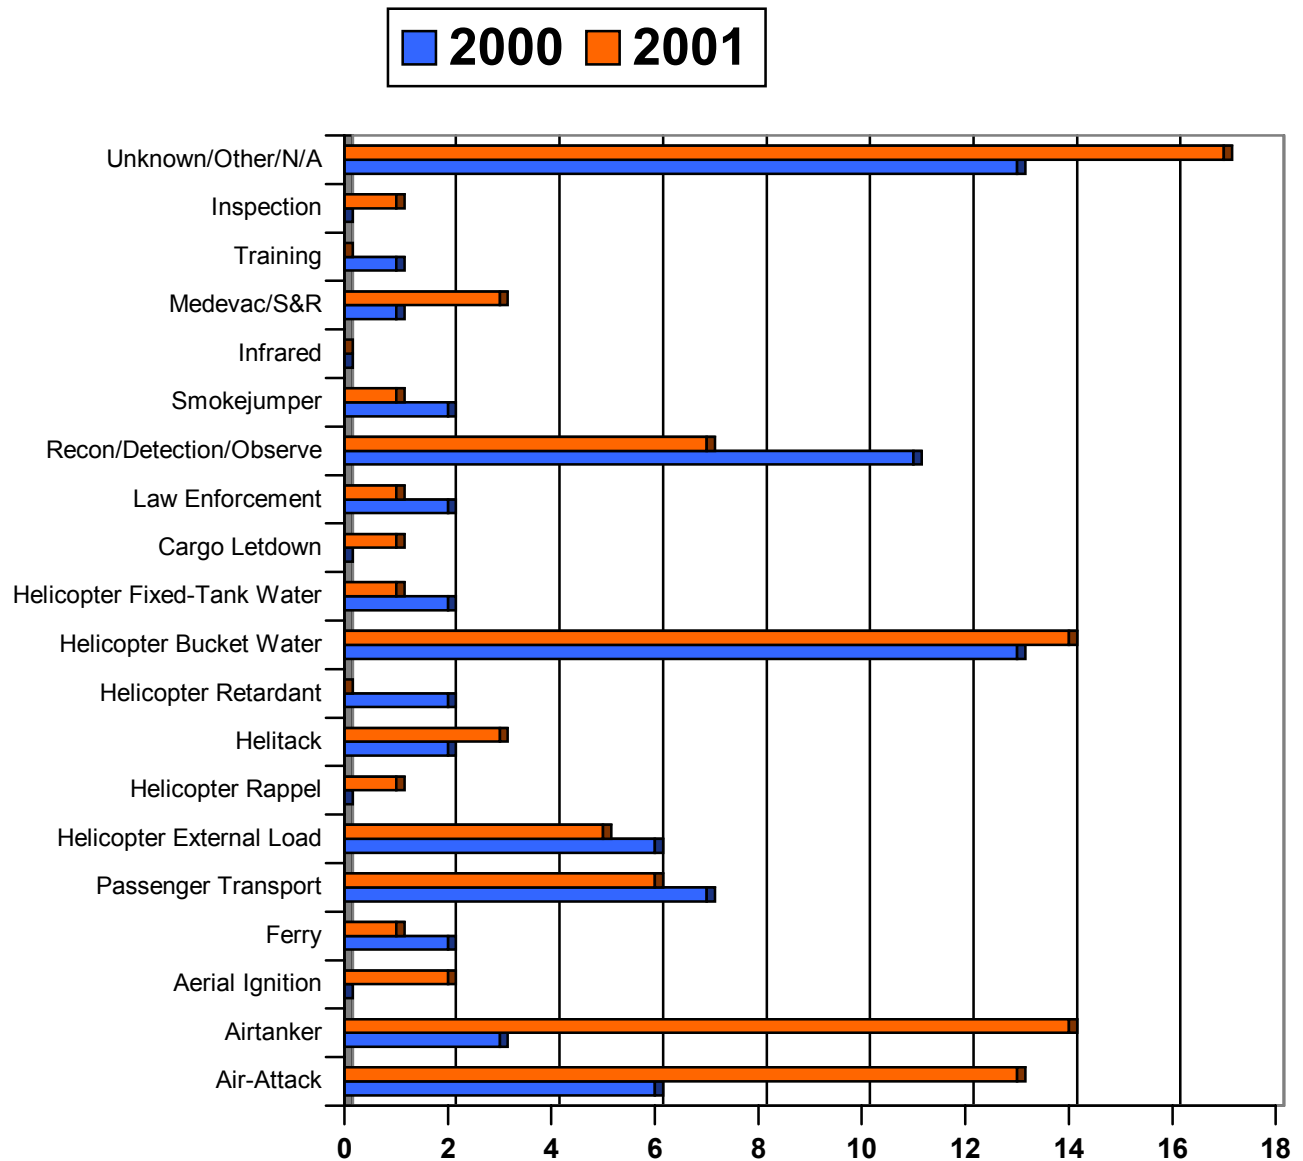
September

Airtanker retardant drop and air-attack mission SafeComs were significantly higher this year than last year. This year helicopter bucket drops and airtanker were equally the highest number of SafeComs reported. Last year helicopter bucket drops were the most reported followed by recon/detection/observation.

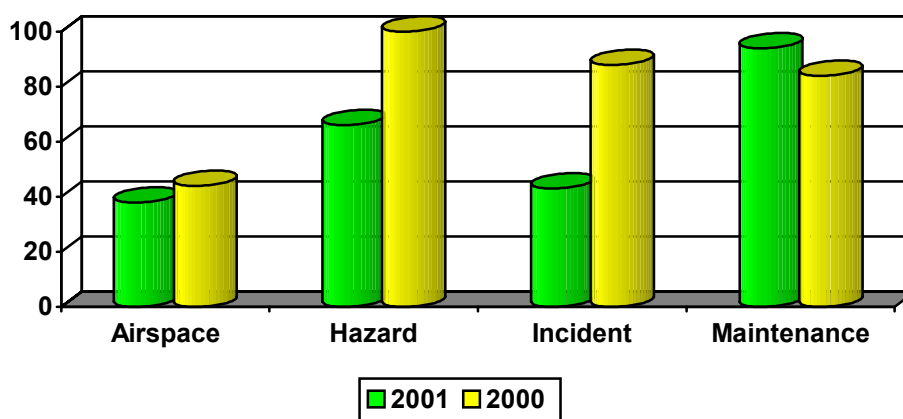
SafeComs on Maintenance are generally the most reported, which is true for this year, but last year hazard were the most reported. This year maintenance SafeComs accounted for 39% compared to 27% last year. Incident SafeComs accounted for only 18% this year compared to 28% last year. Hazard SafeComs were slightly less this year, down to 27% from 31% last year. The chart below shows the number of SafeComs reported by category for August of this year and last year.

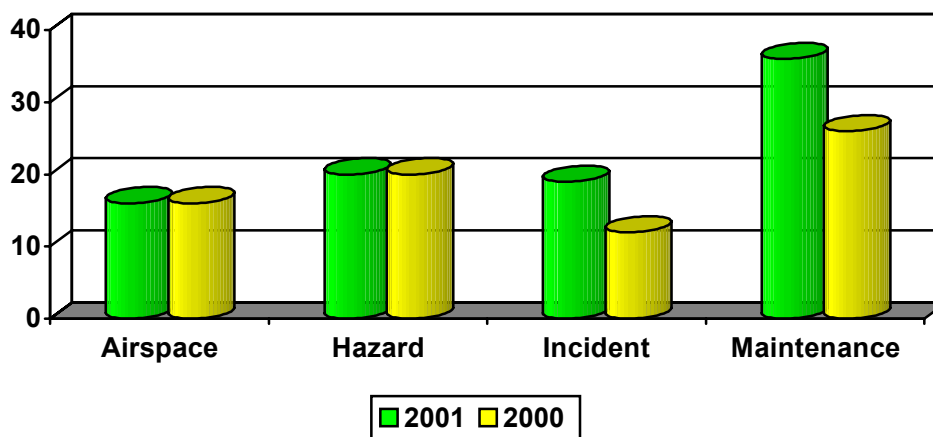
In September Maintenance SafeComs again were back in the normal trend of having the most reported for both years. Maintenance SafeComs accounted for 39% of the SafeComs this year and 35% last year. Hazards were the second highest at 22% this year and 27% last year. Incidents came in at 21% this year up from 16% last year, while airspace were down to 18% from 22% last year. The chart below shows the number of SafeComs reported by category for September of this year and last year.

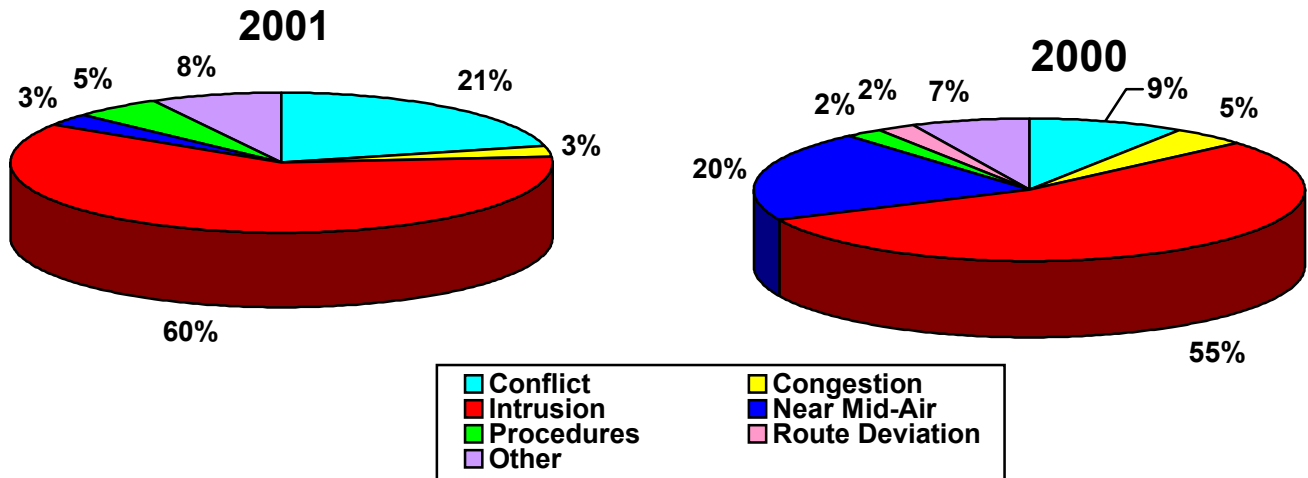
There were 38 SafeComs reported in this category in August this year compared to 44 last year. The best news is that the number of near mid-air SafeComs dropped to one this year from 9 last year. There was twice as many conflict SafeComs this year, 8 compared to 4 last year. There were 23 intrusions this year and 24 last year. The charts below show the percent of Airspace SafeComs by sub-category for August of this year and last year.

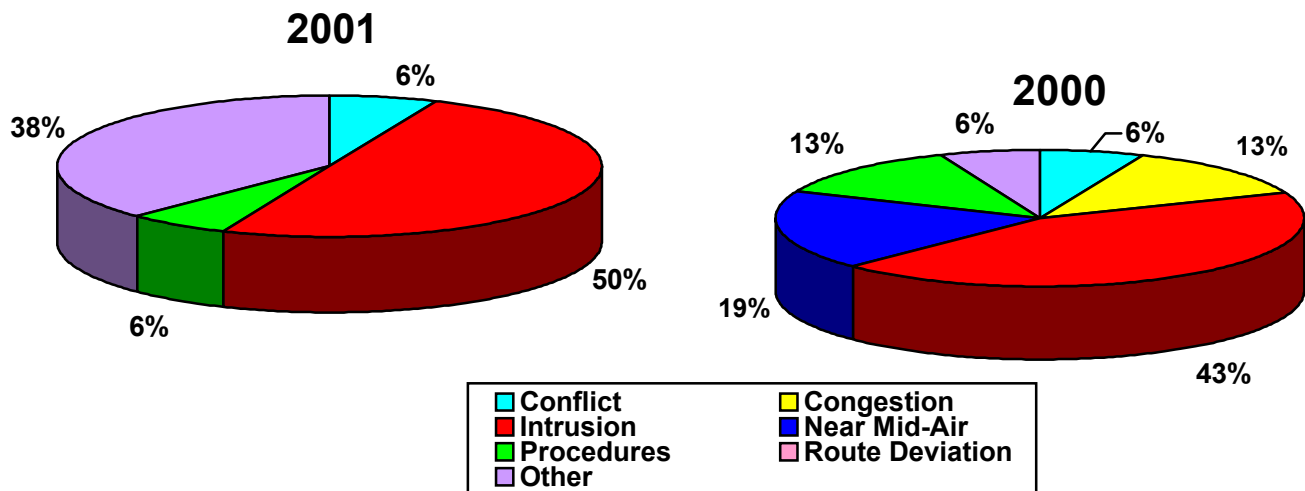
There were 16 SafeComs reported in this category in September for both this year and last year. NO near mid-air SafeComs were reported this year, there were three reported last year. Intrusions remain the highest reported in this category. The charts below show the percent of Airspace SafeComs by sub-category for September of this year and last year.

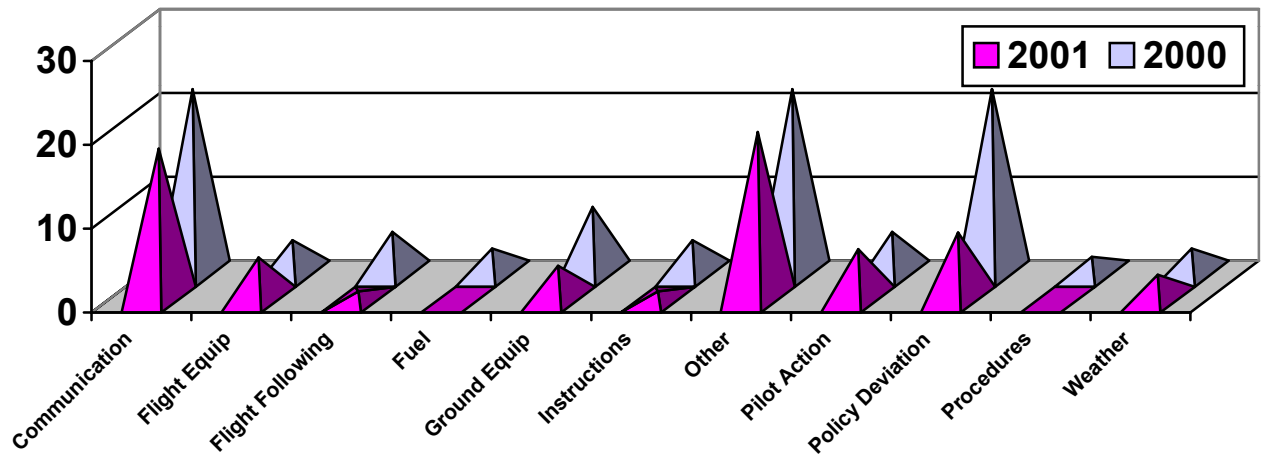
There were 66 SafeComs reported in this category this year compared to 100 last year. Communications, as usual continue to peak out in this category! They accounted for 28% of the Hazard SafeComs this year and 23% last year. Policy deviations were considerably lower this year, 12% this year compared to 22% last year. The chart below shows the number of Hazard SafeComs reported by sub-category for August of this year and last year.

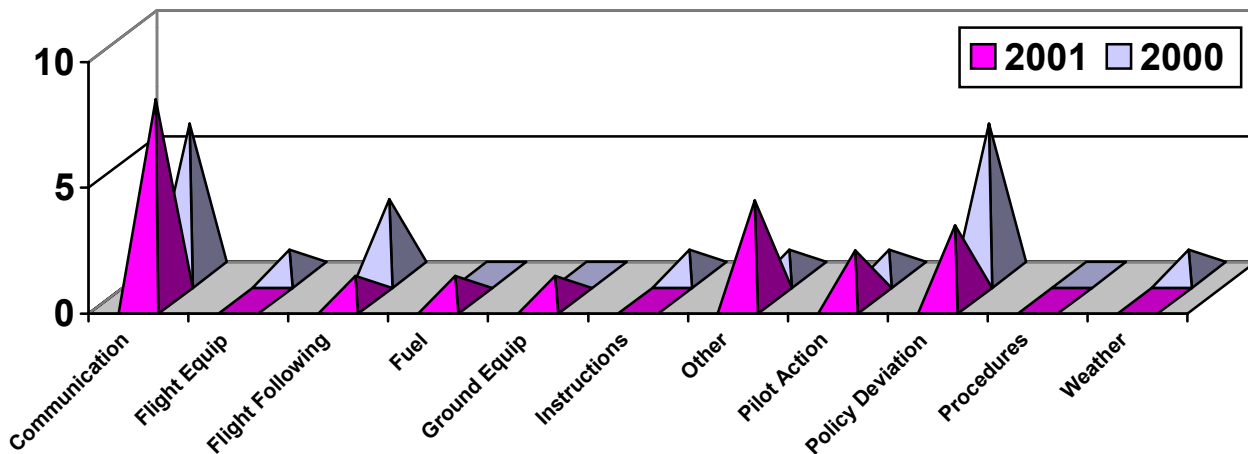
There were 20 SafeComs reported in this category both this year and last year. Communications accounted for 40% of the SafeComs this year and 30% last year. Policy deviation SafeComs were half of last year at 15% this year and 30% last year, and flight following was significantly lower at 5% this year from 15% last year. Pilot actions were twice as much this year at 10% from 5% last year. The chart below shows the number of Hazard SafeComs reported by sub-category for September of this year and last year.

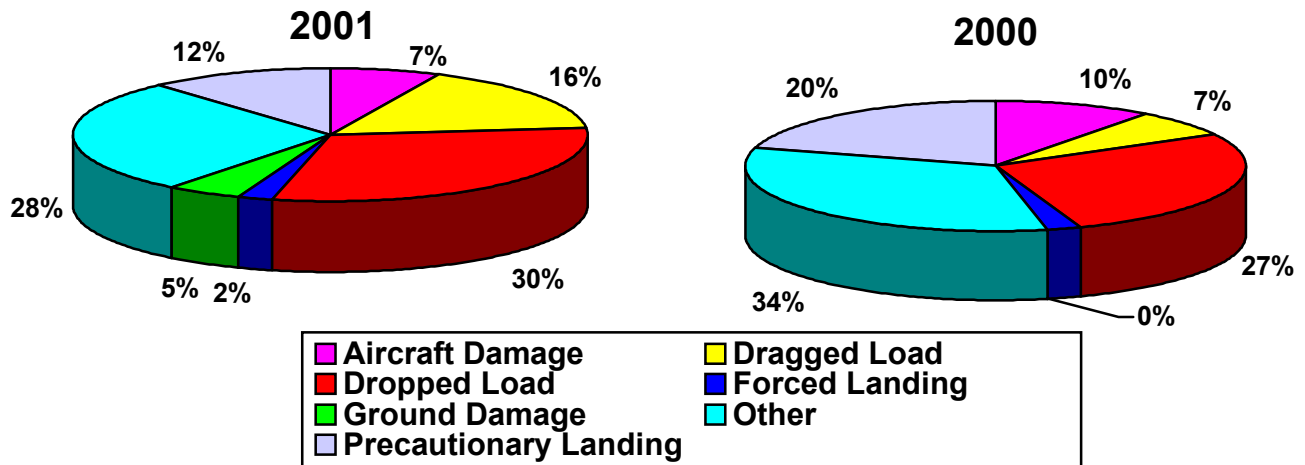
There was less than half the number of SafeComs reported in this category in August, 43 this year and 88 last year. Dropped and dragged loads accounted for almost half of the SafeComs in this category this year; dragged loads were significantly higher, more than double. The charts below show the percent of Incident SafeComs by sub-category for August of this year and last year.

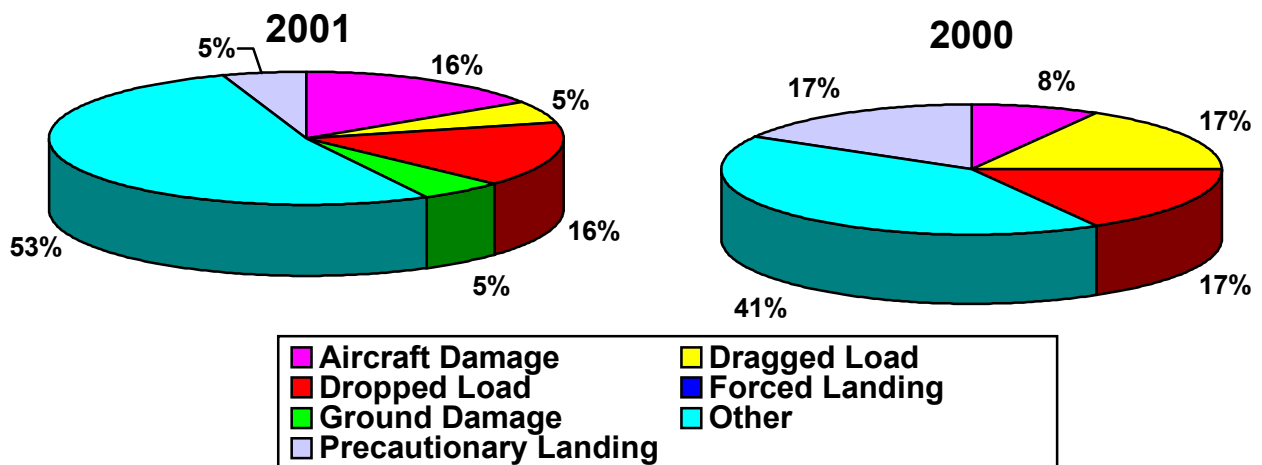
In September there were 19 Incident SafeComs reported this year compared to 12 last year. Dropped loads and aircraft damage were the most reported this year while dragged loads were down considerably from last year. Last year Dragged and dropped loads and precautionary landings were equally the highest. The charts below show the percent of Incident SafeComs by sub-category for September of this year and last year.

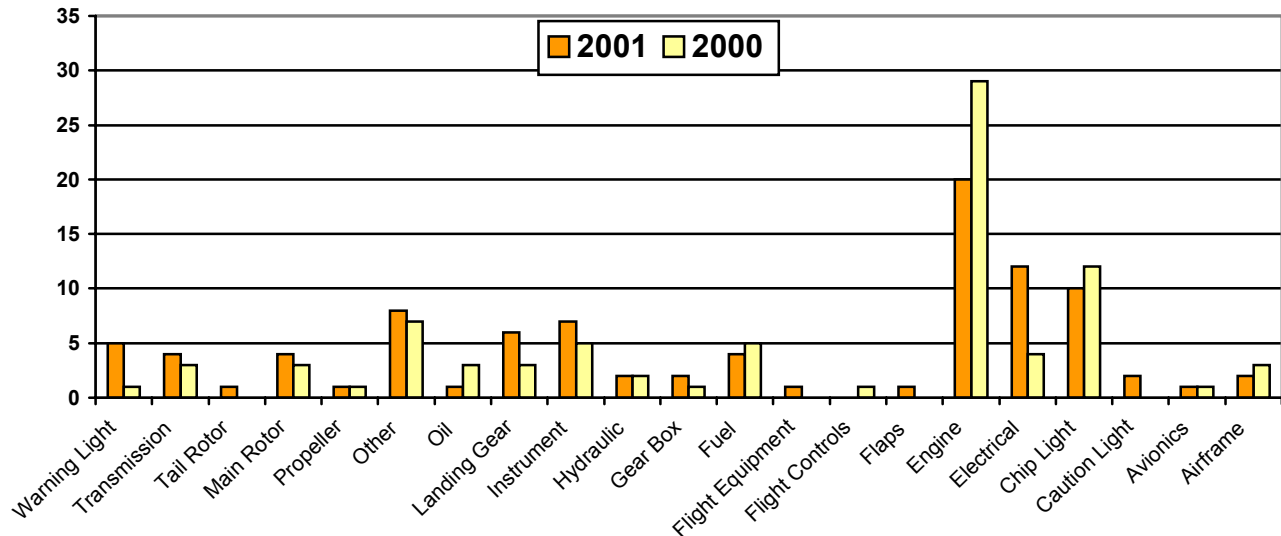
There were 94 Maintenance SafeComs reported this year compared to 84 last year. Engine followed by electrical then chip light were the most reported this year. Engine followed by chip light then instrument and fuel were the most reported last year. The chart below shows the number of Maintenance SafeComs reported by sub-category for August of this year and last year.

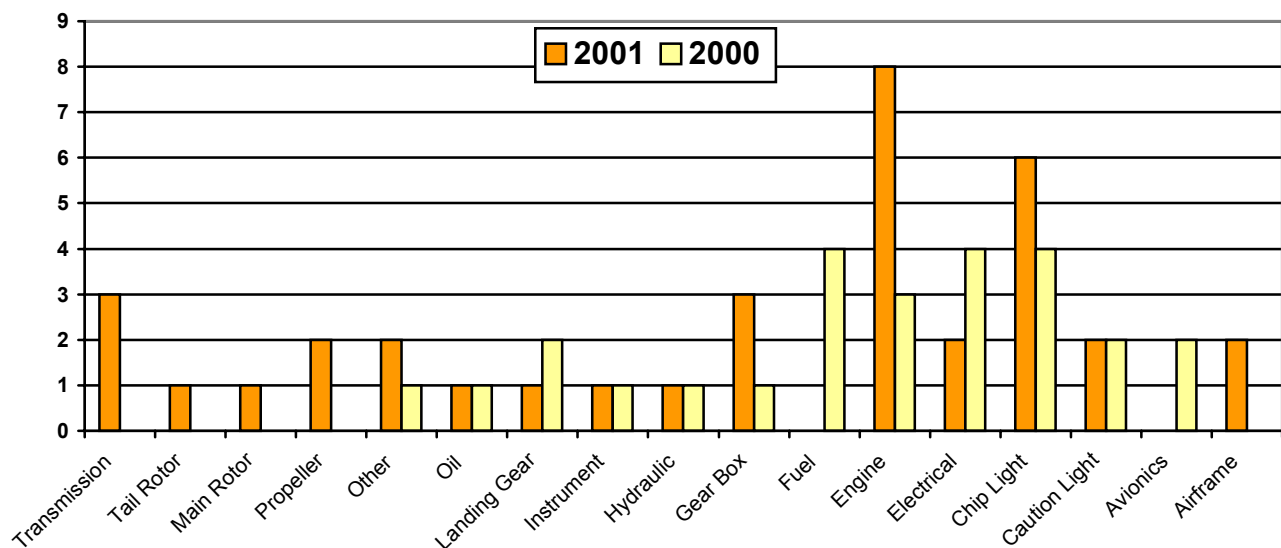
There were 36 Maintenance SafeComs reported this year compared to 26 last year. Engine followed by chip light were the most reported this year. Last year Fuel, electrical and chip light were equally the most reported last year. The chart below shows the number of Maintenance SafeComs reported by sub-category for September of this year and last year.
